# RESTORATION OF THE OTTOMAN BATH (HAMMAM)

*Kastellorizo island, Greece*

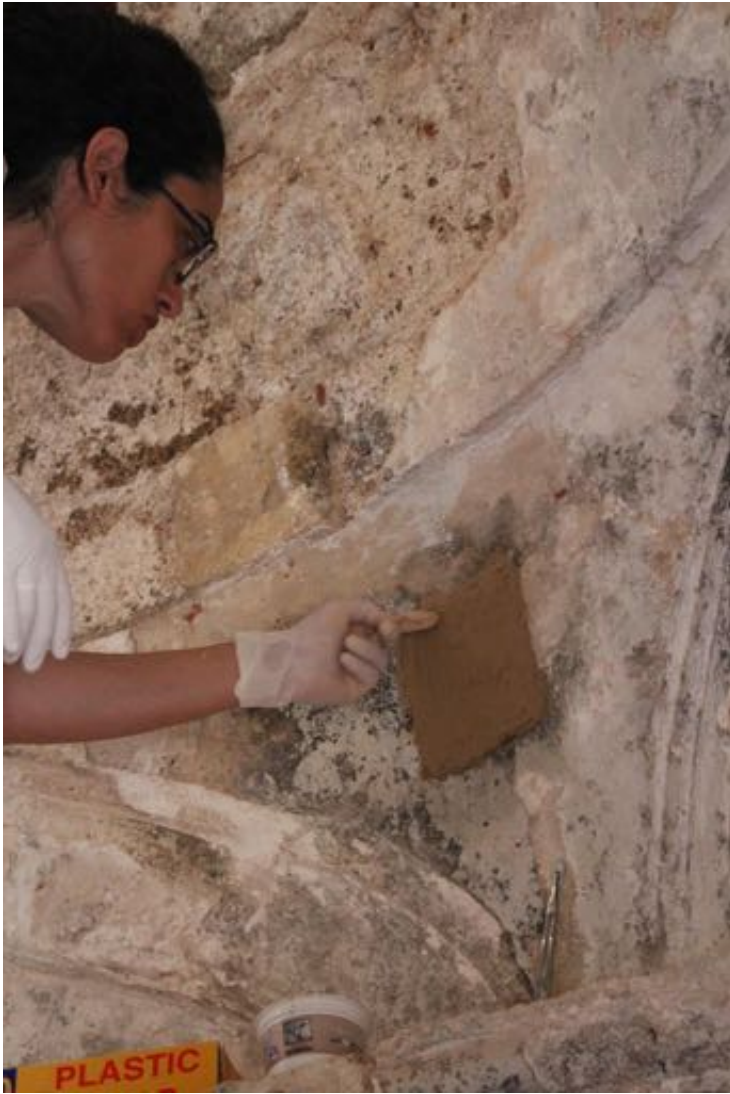
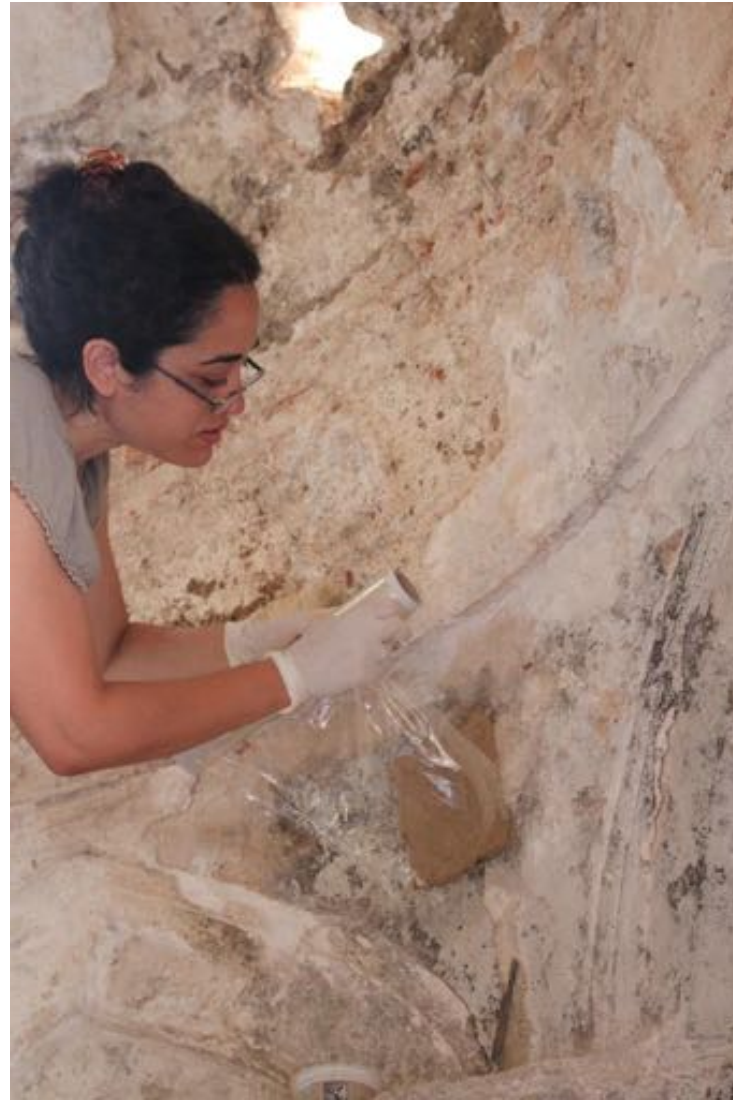
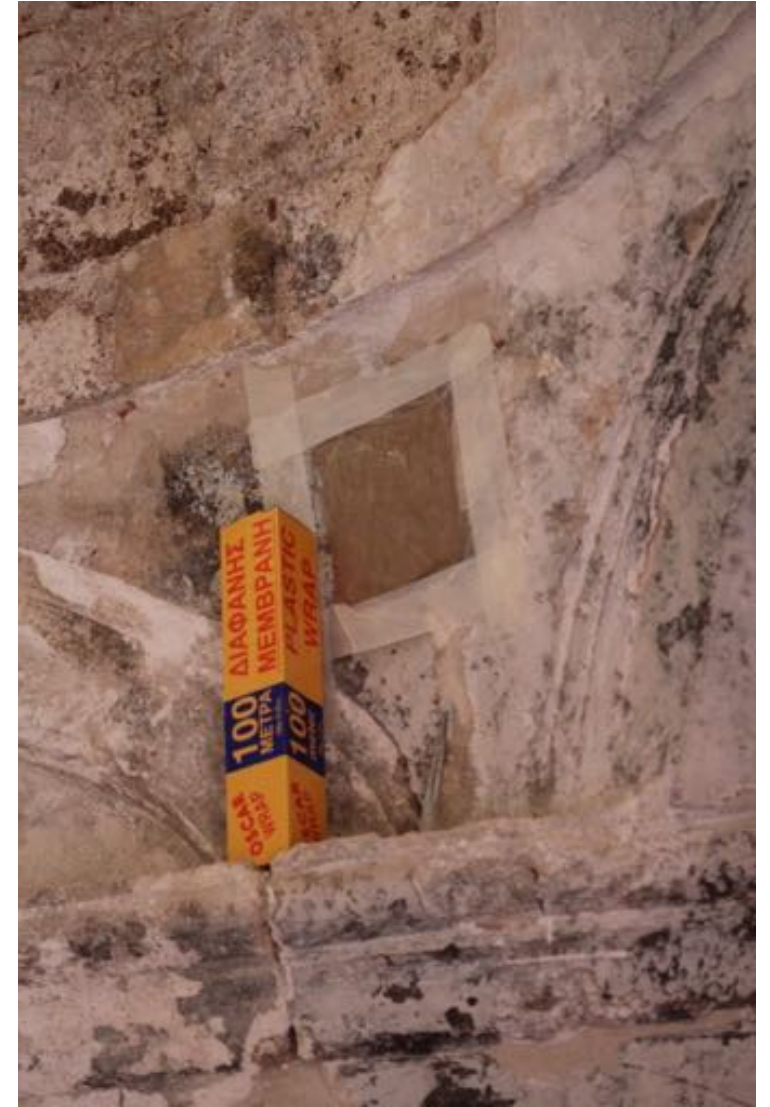
# Testing the cleaning for the surfaces under the dome with sepiolite

*conservation*

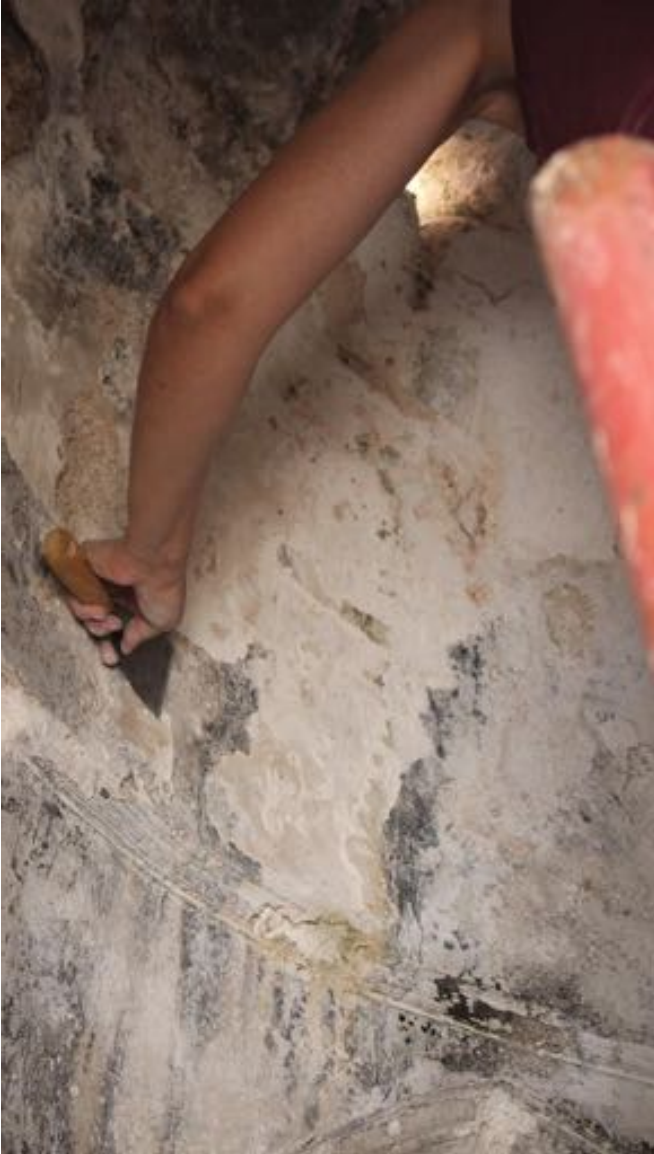
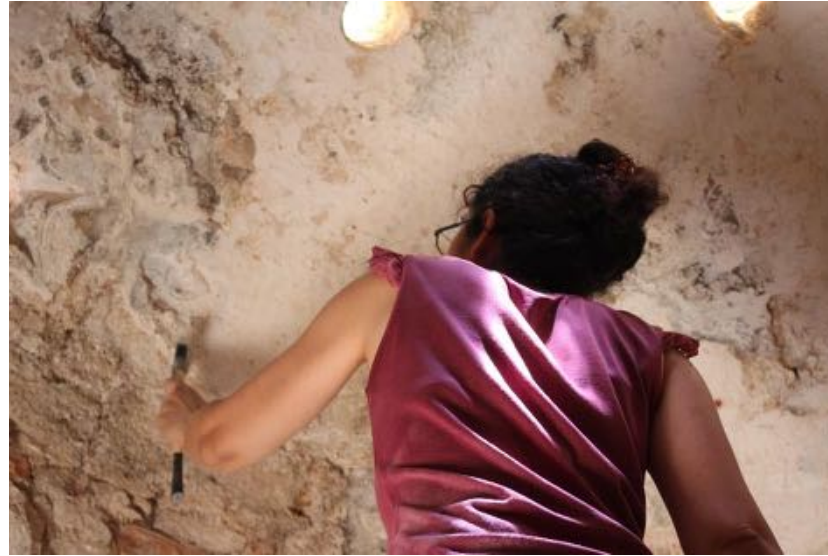
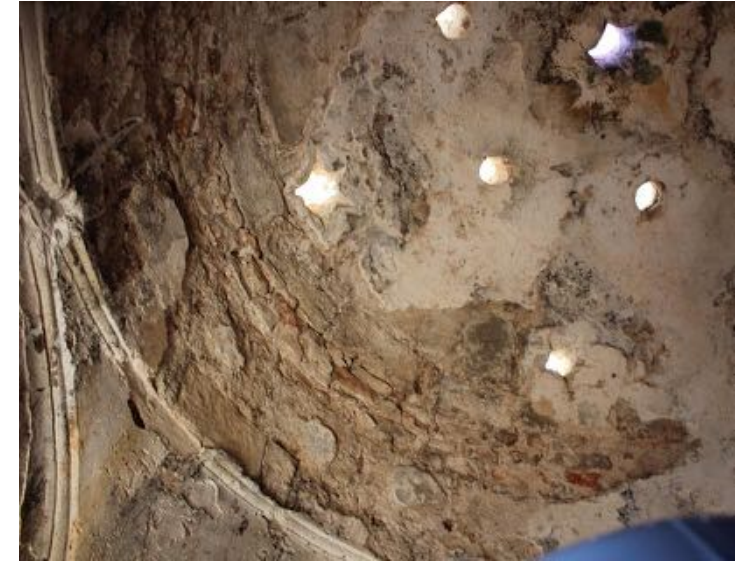
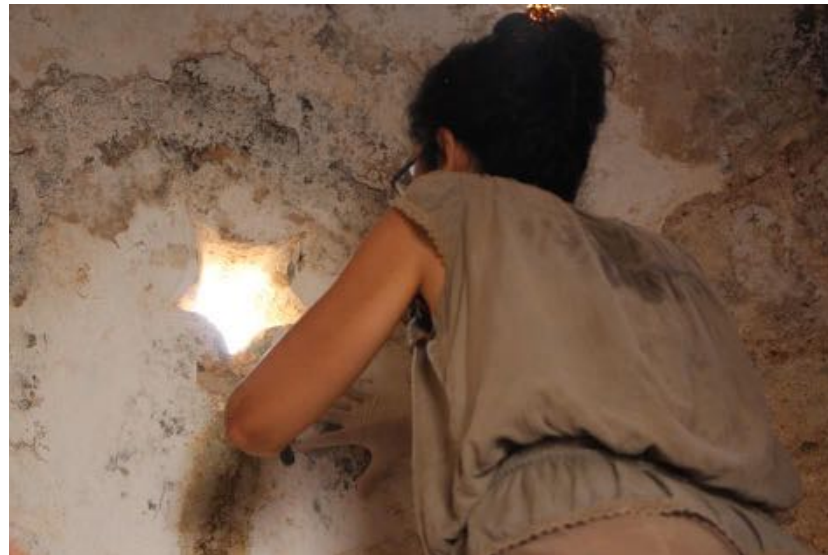
# Checking the stability of coating at the dome

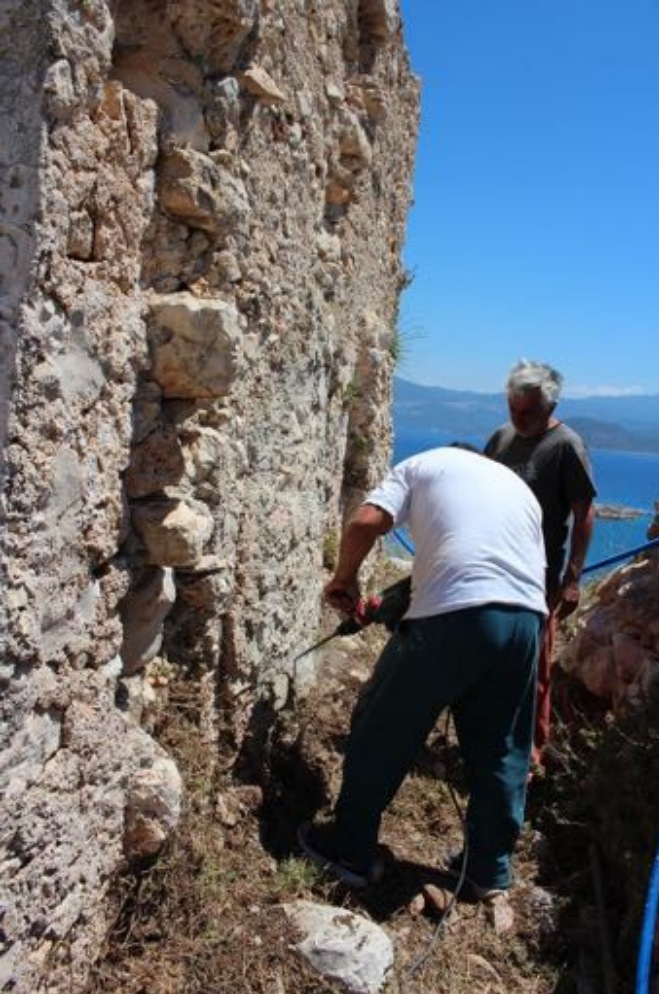
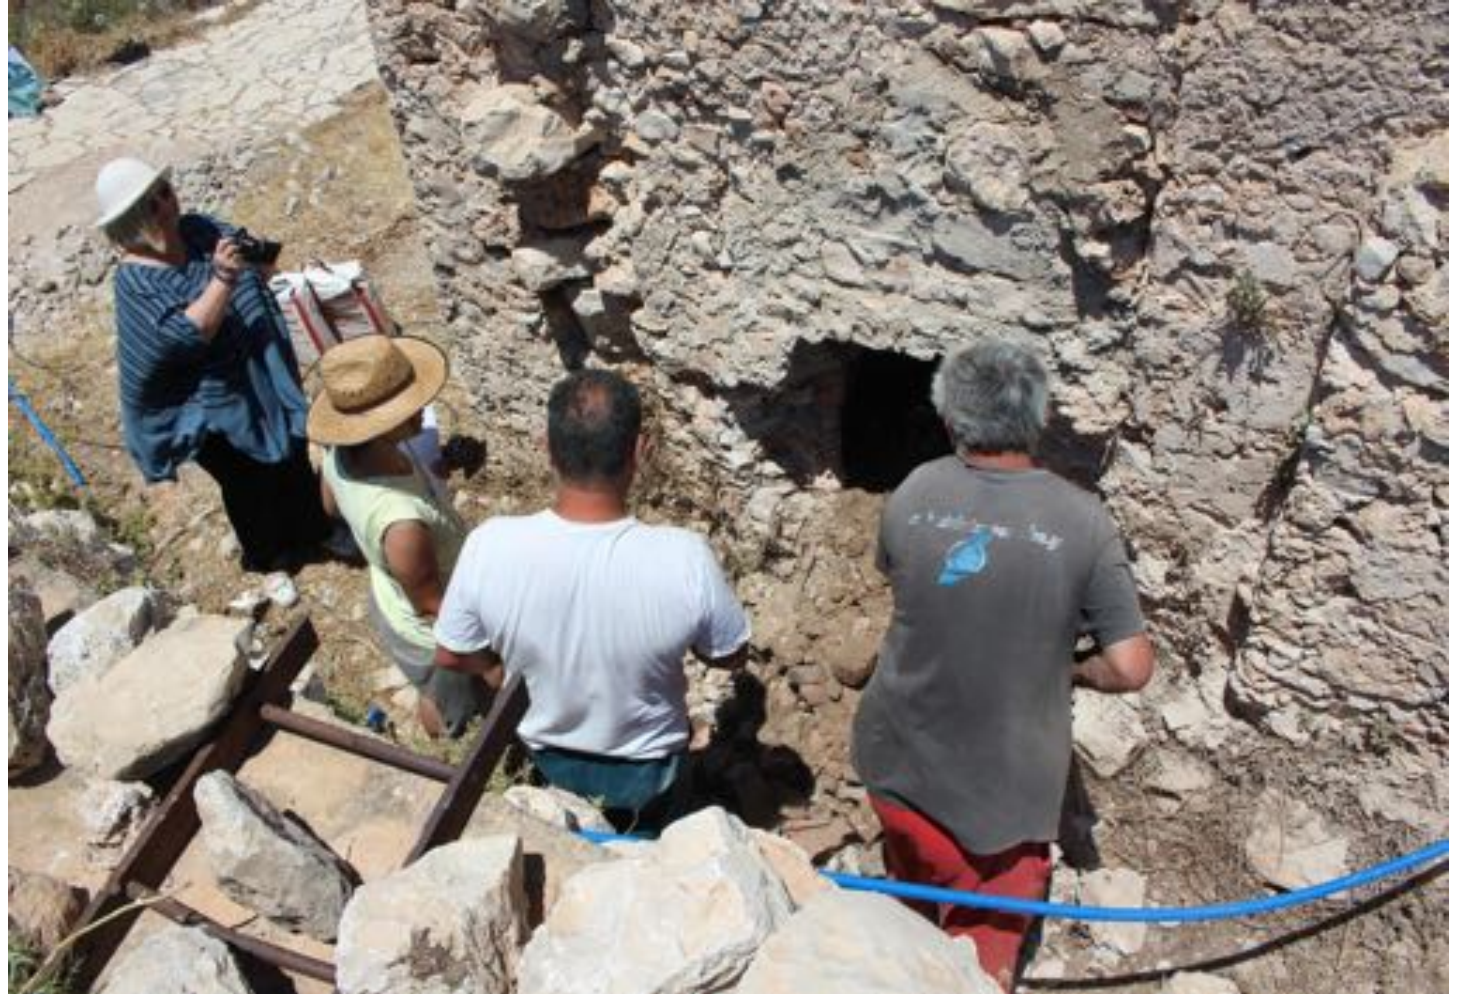
## Boiler department (furnace)

*Opening of blocked entrance of the furnace*

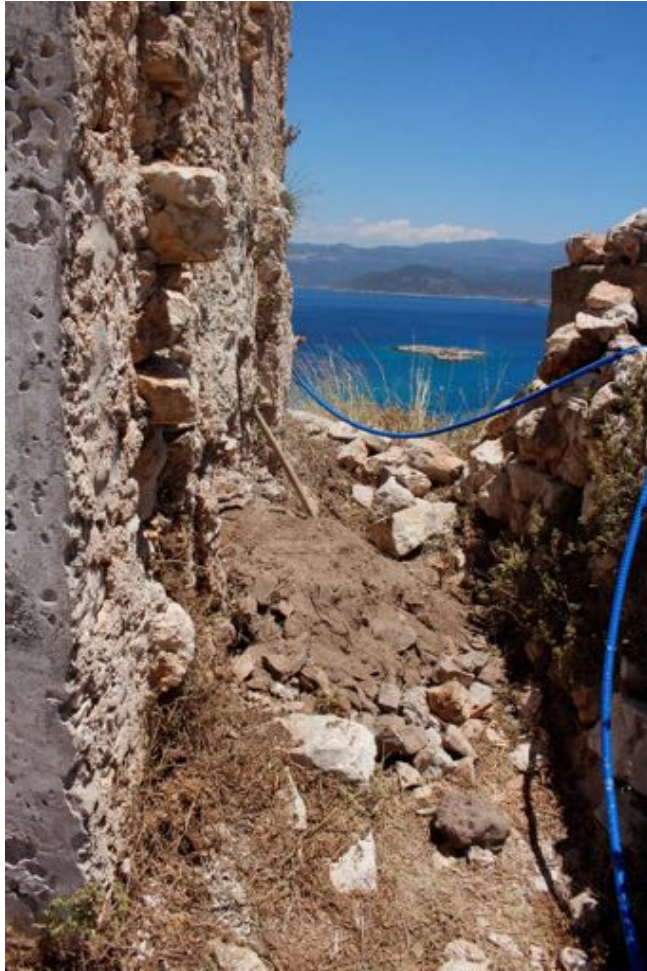
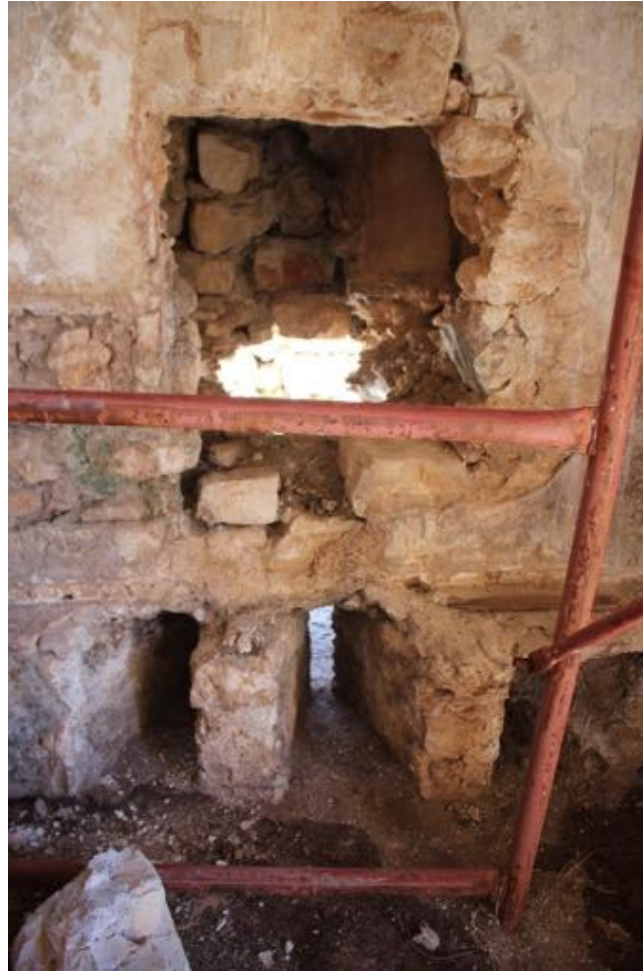
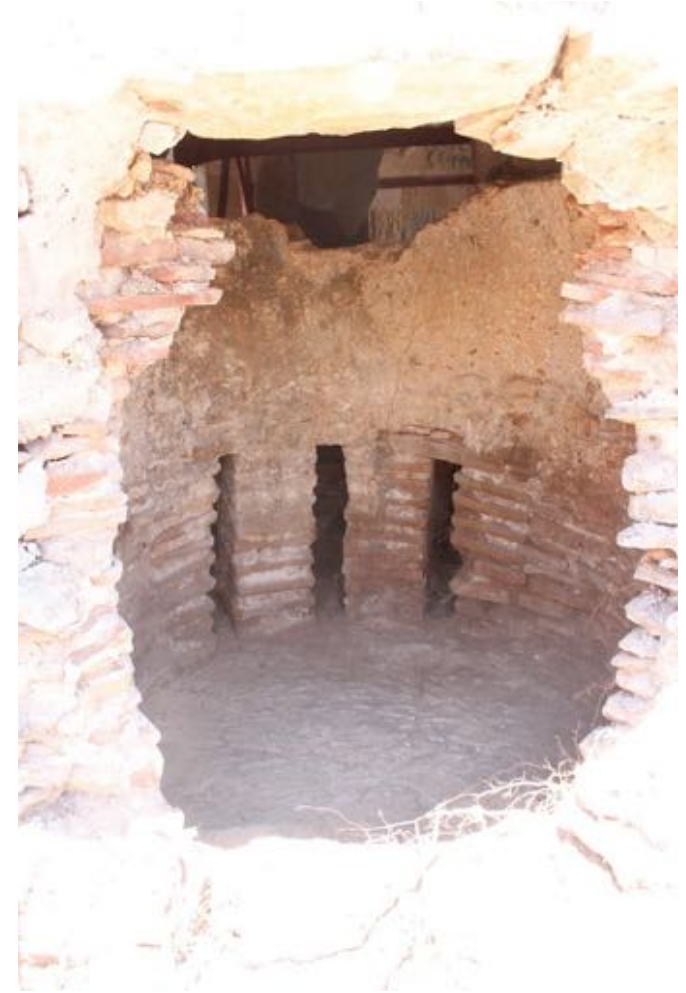
## Boiler department (furnace)

*Cleaning of the furnace-three outputs for the hypocaust heating system*

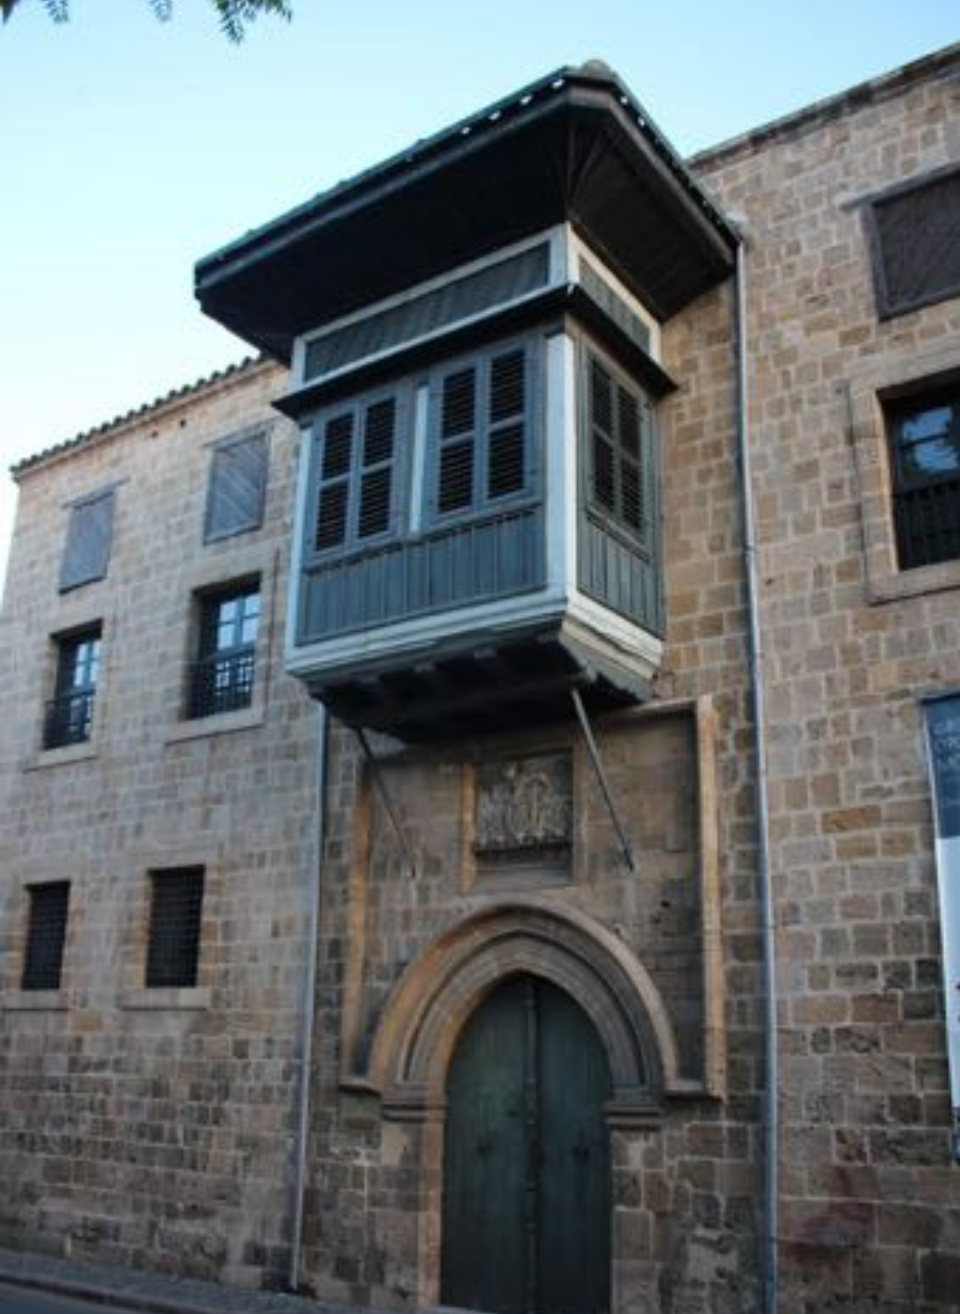
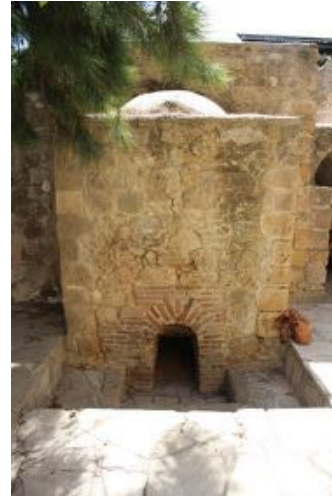
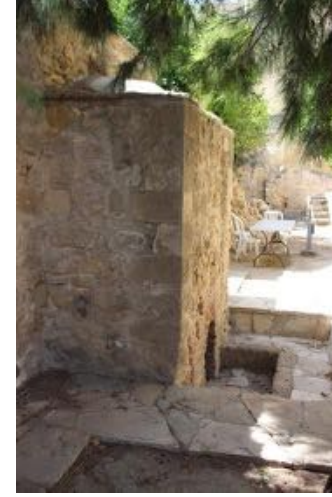
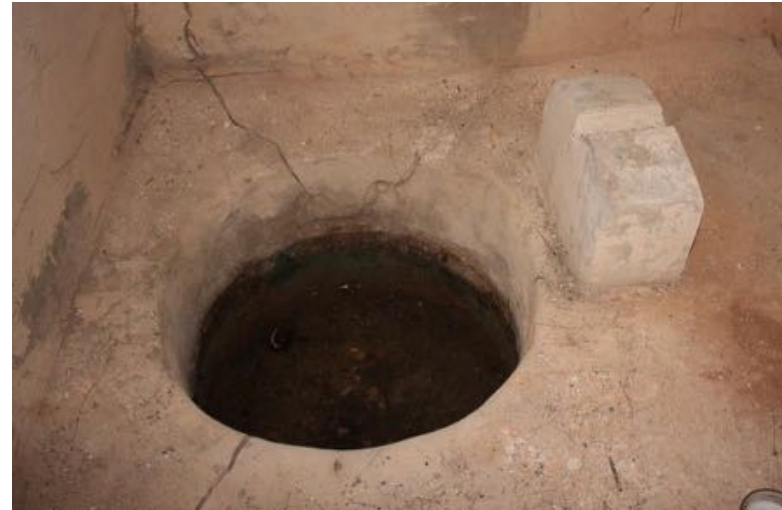
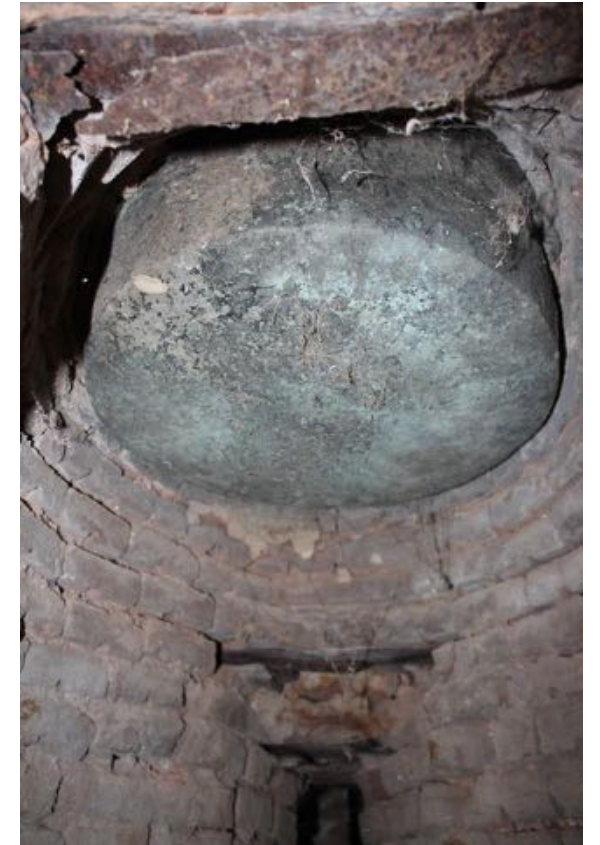
## Boiler department (furnace)

*Comparative examination with the hammam at the Komninos Chadjigeorgakis' Mansion at Nicosia Cyprus*

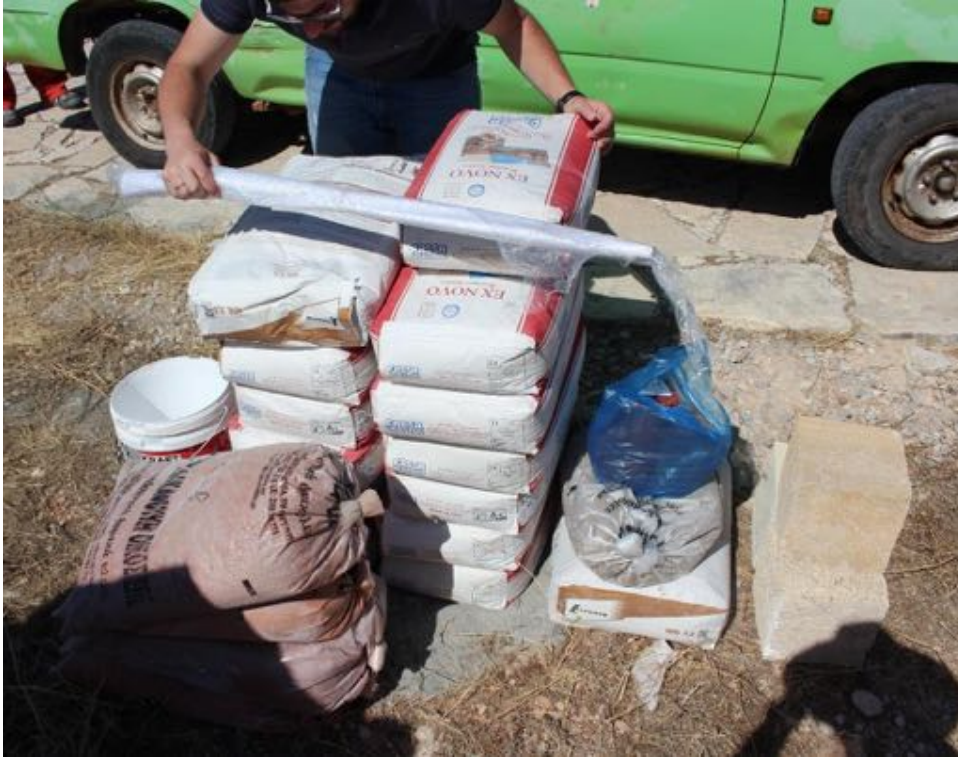
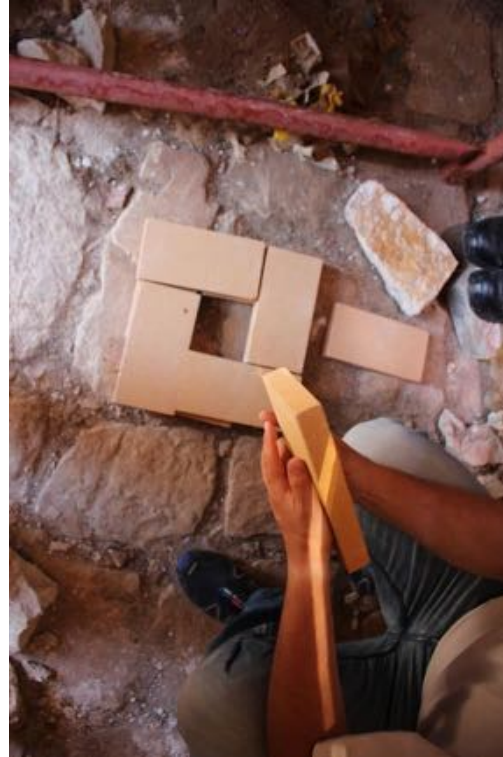
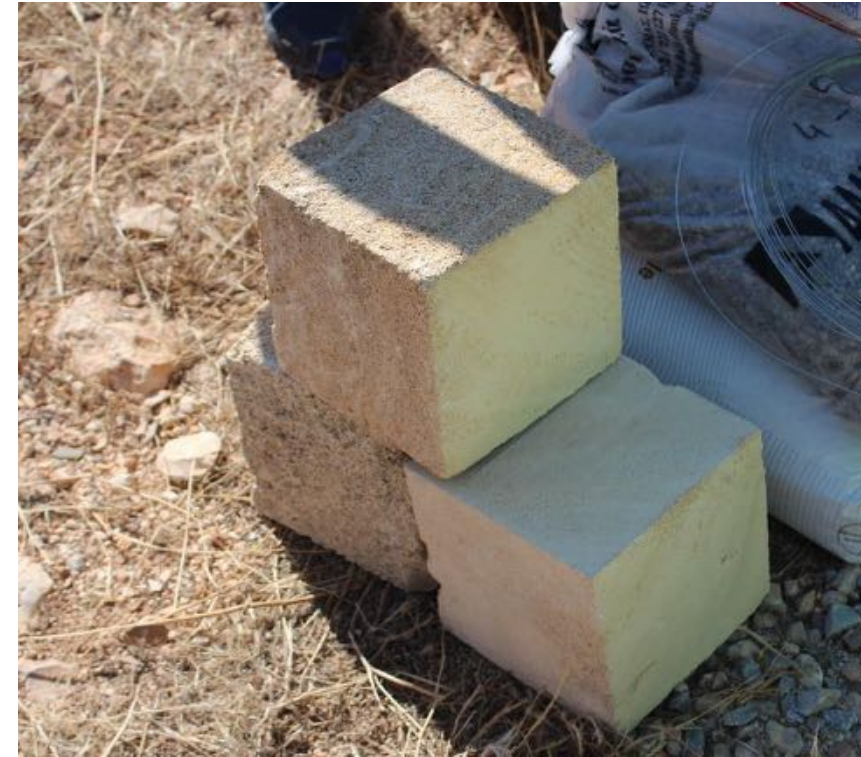
# Building materials

*Mortars- firebricks- sandstones*

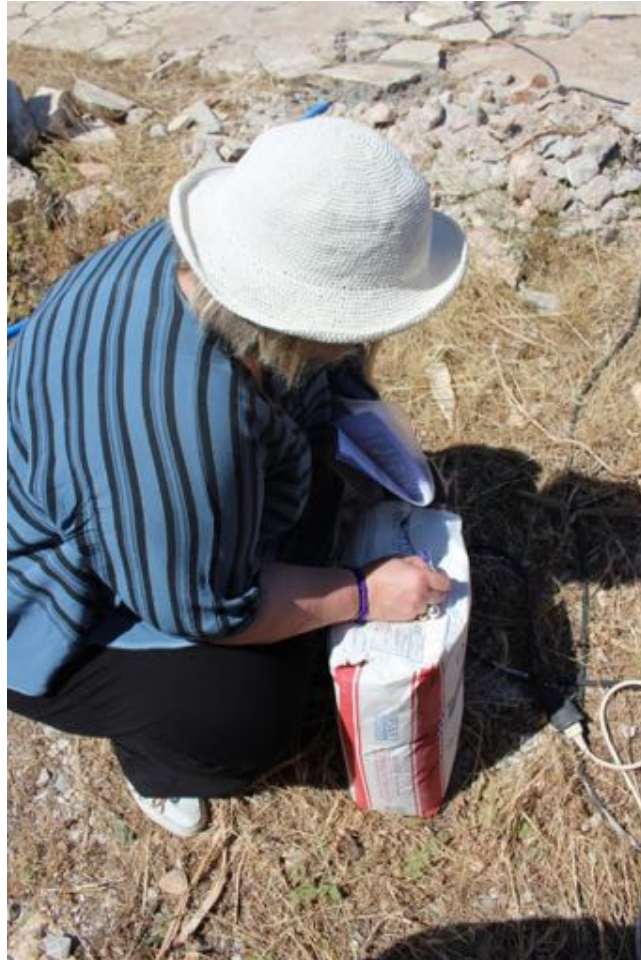
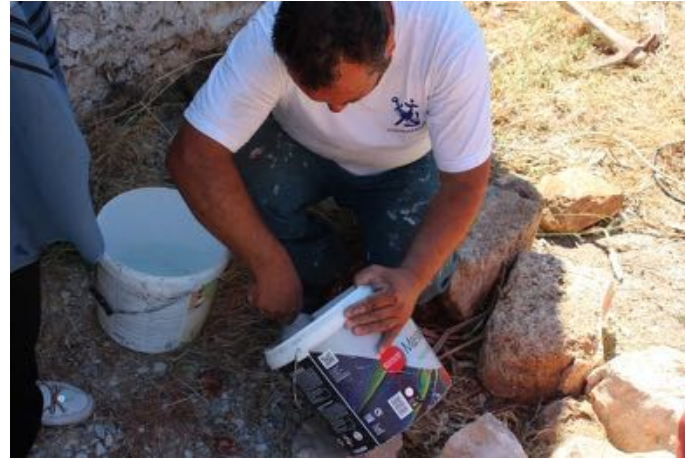
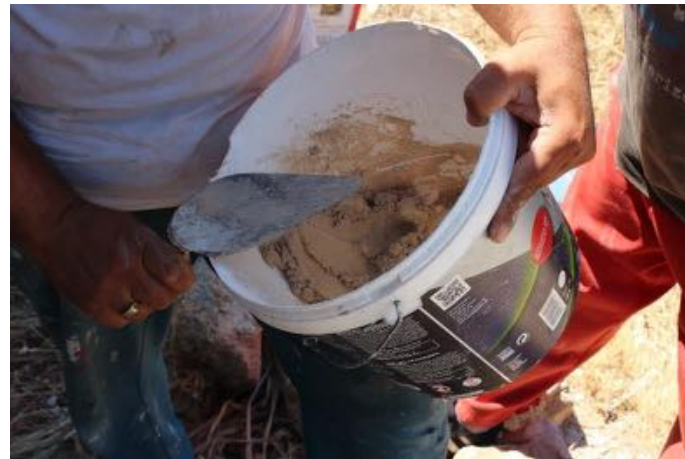
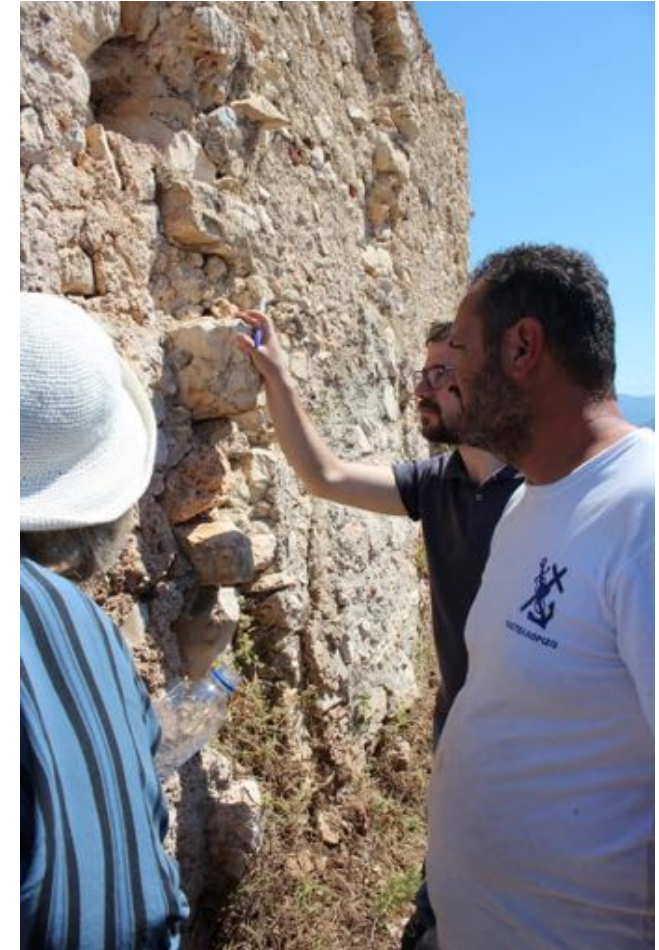
# Samples for different kind of mortars

*Malta di alletamento 770 –grouting mortar*

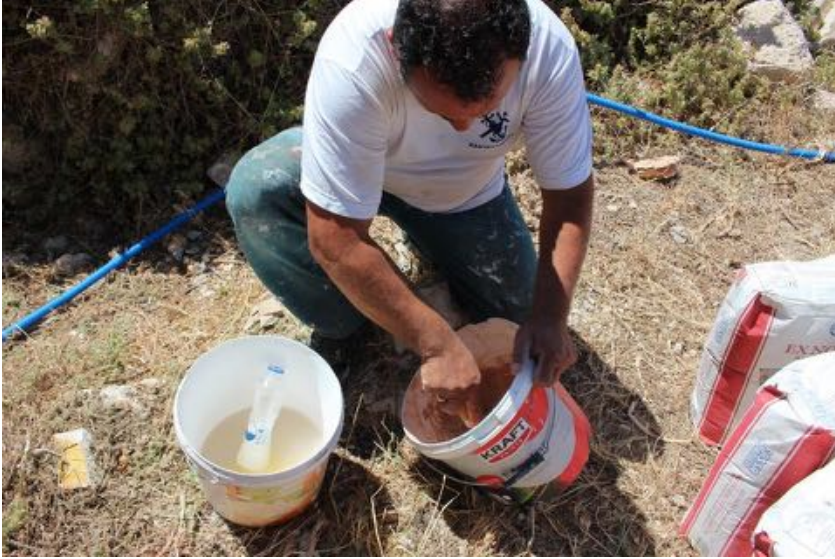
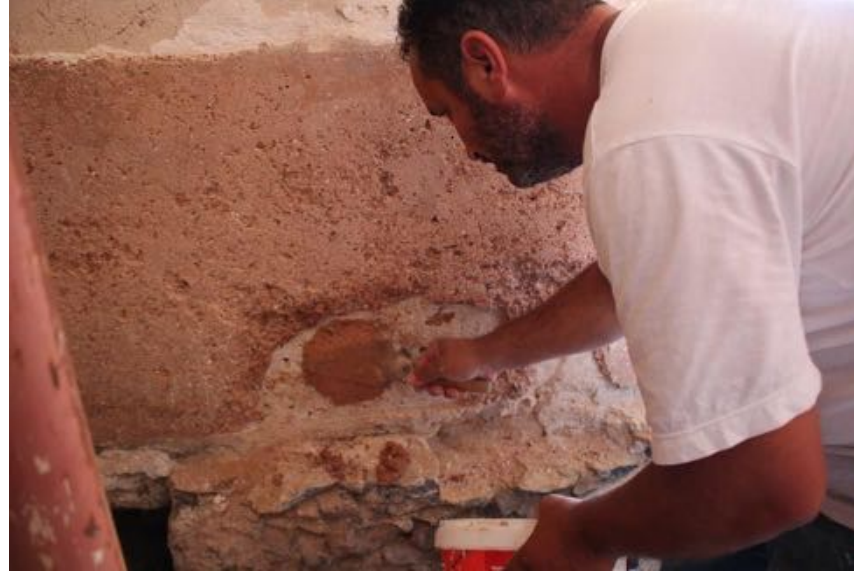
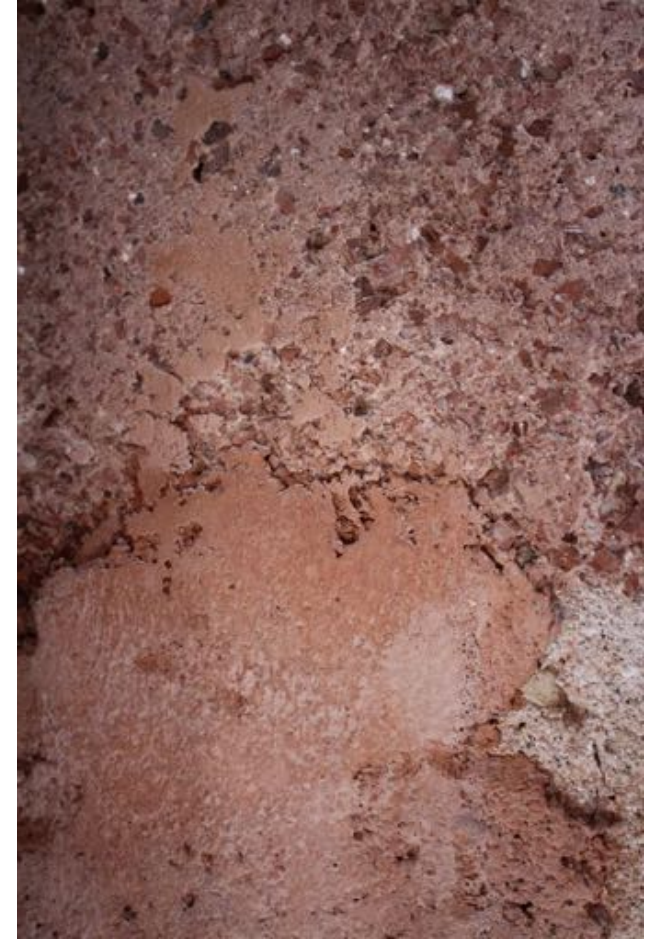
# Samples for different kind of mortars

*Cocciopesto macroporoso 740- Ceramic shard*

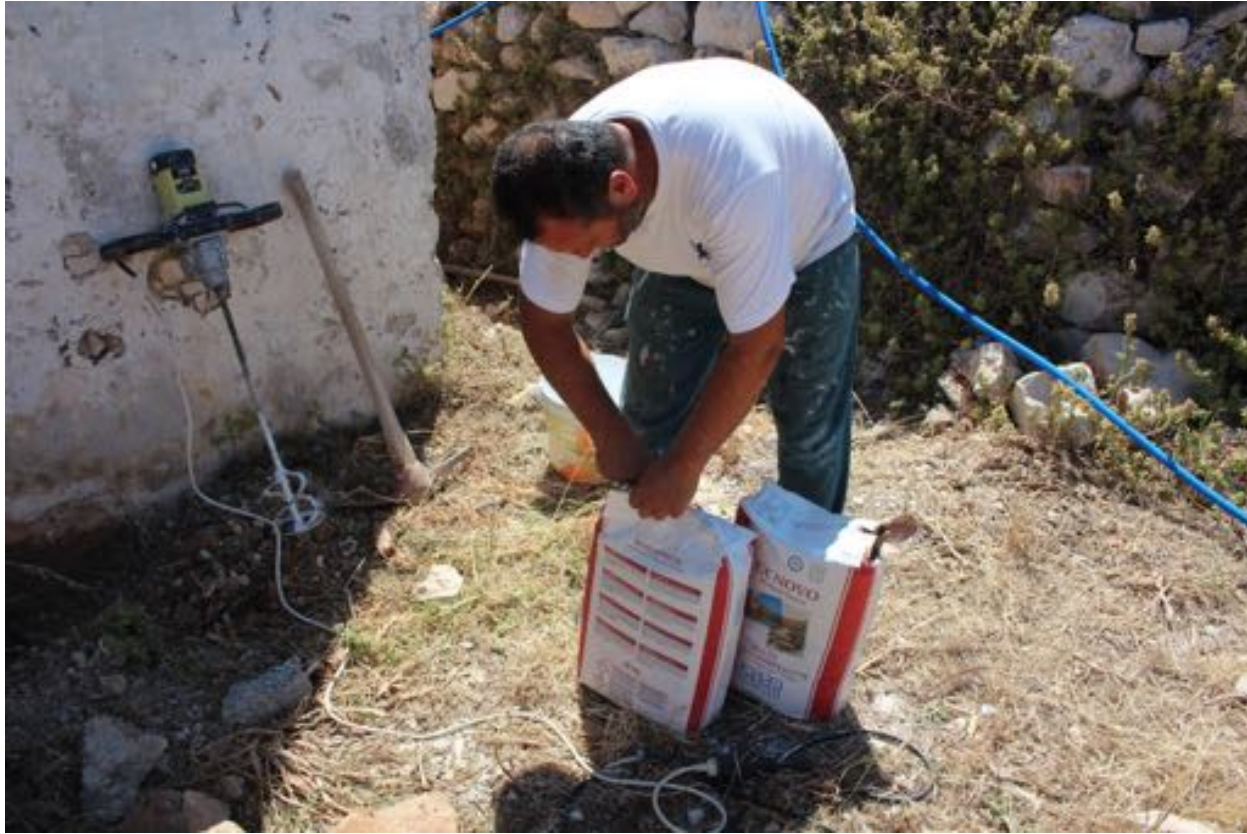
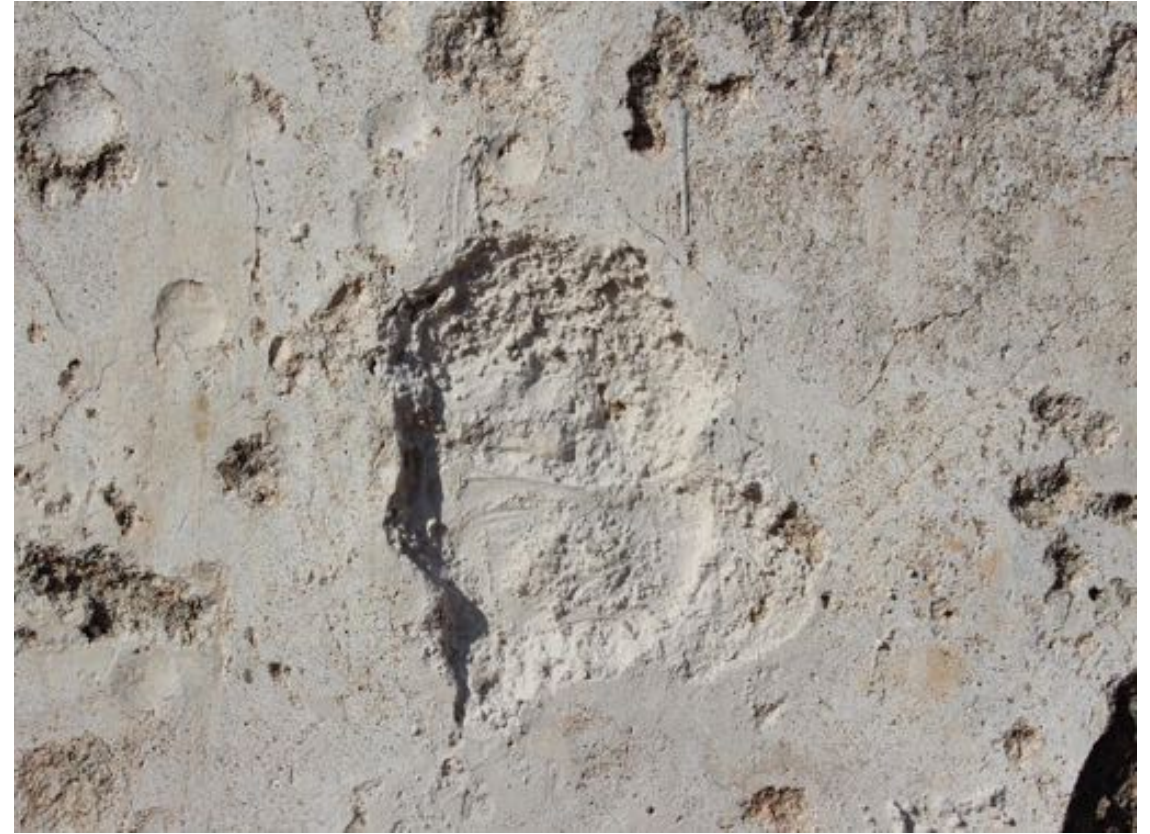
# Samples for different kind of mortars

*Rinzaffo 720 – Primer coating*

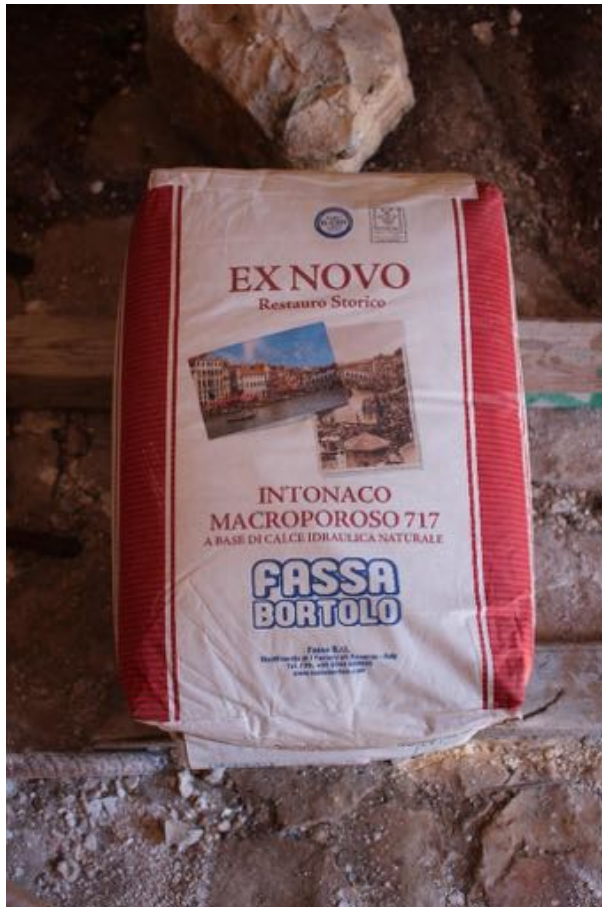
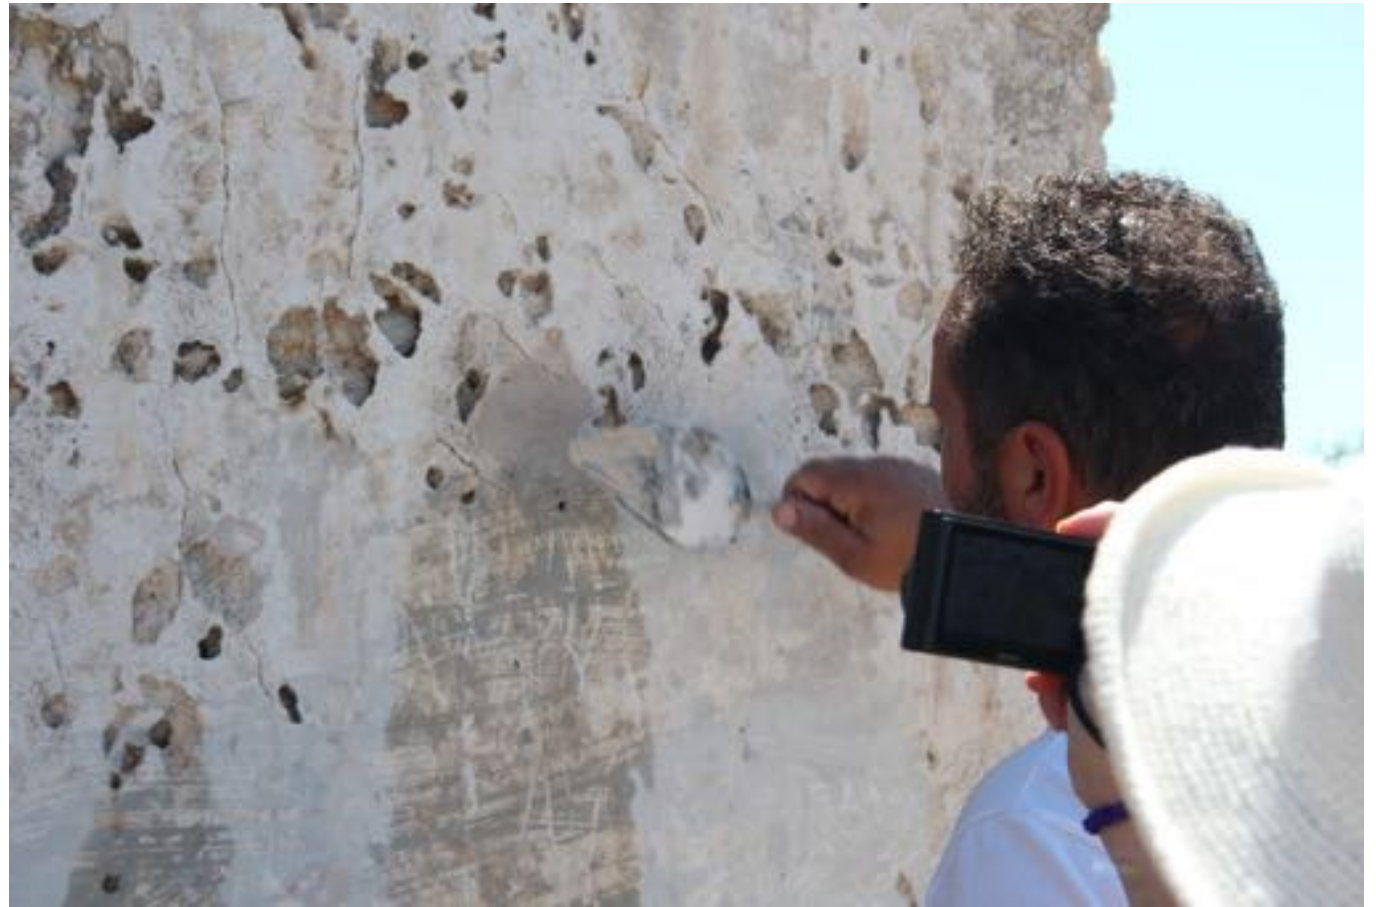
# Samples for different kind of mortars

*Macroporoso 717 – Thick coating*

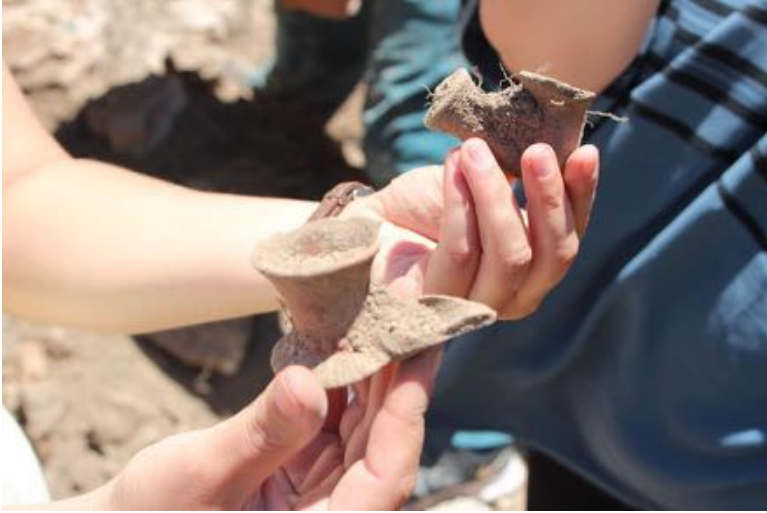
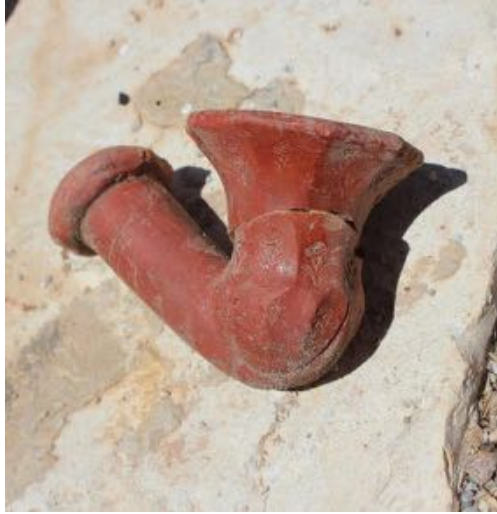
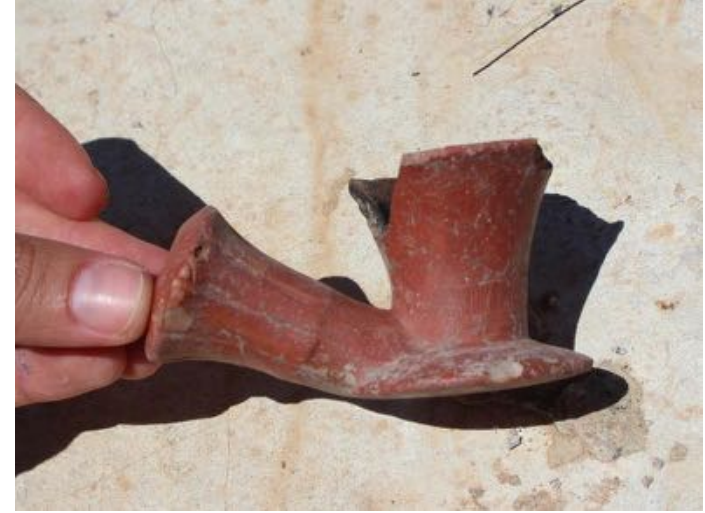
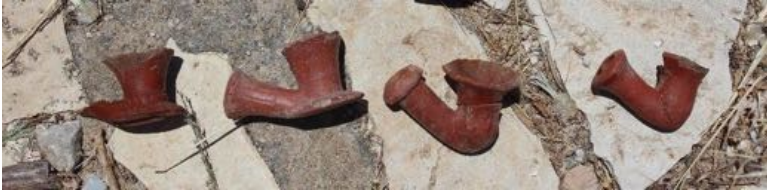
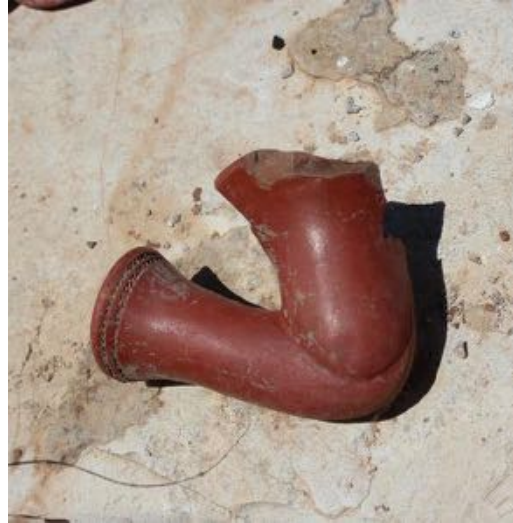
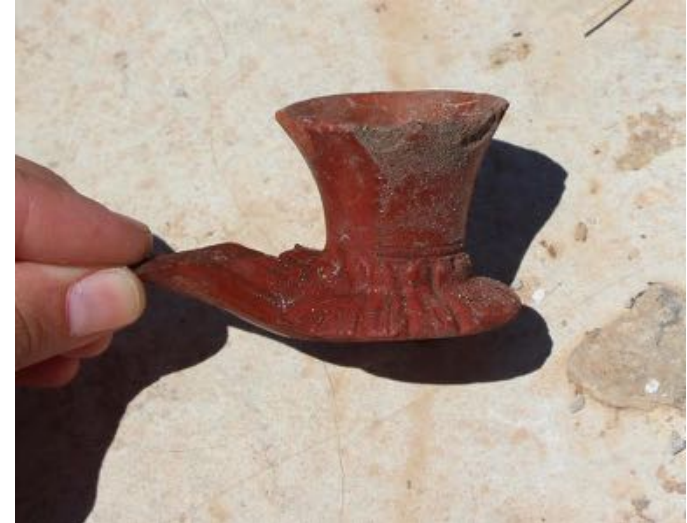
# Turkish ceramic pipes

*Findings inside the blocked furnace*
