# RESTORATION OF THE OTTOMAN BATH (HAMMAM)

*Kastellorizo island, Greece*

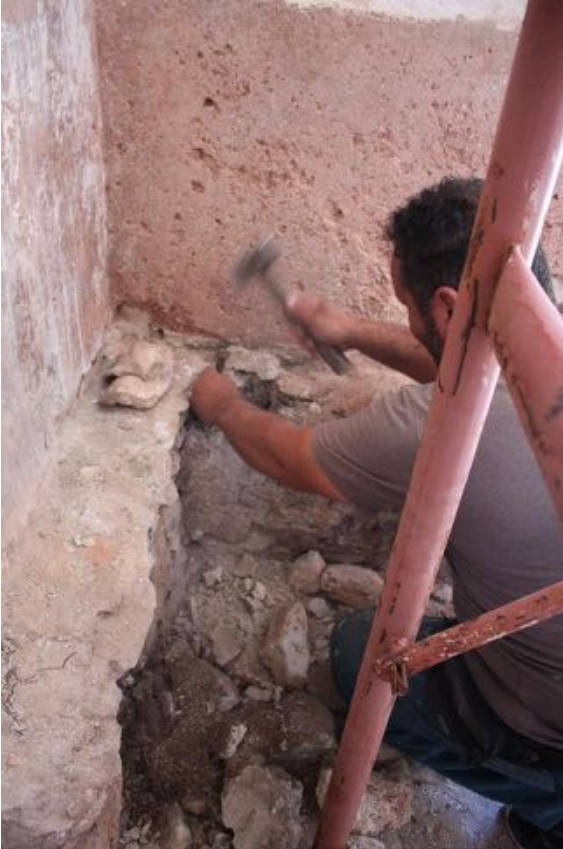
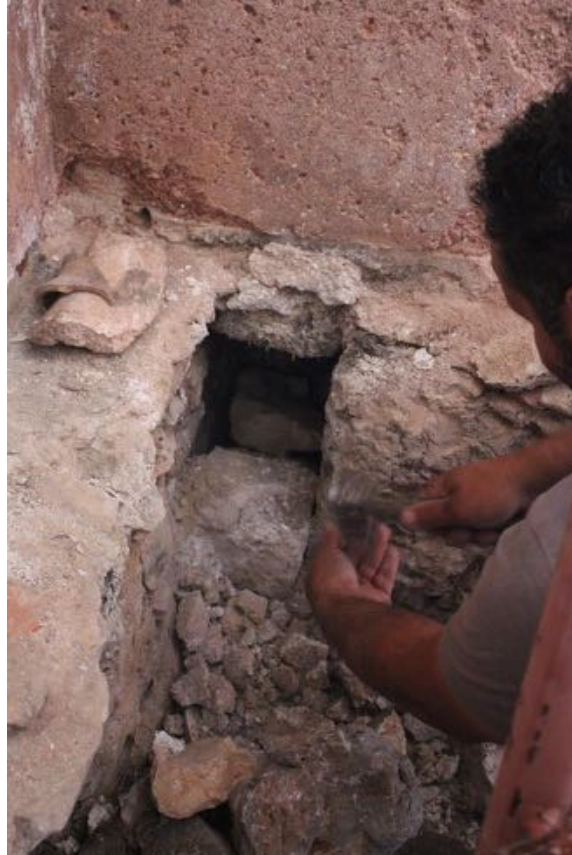
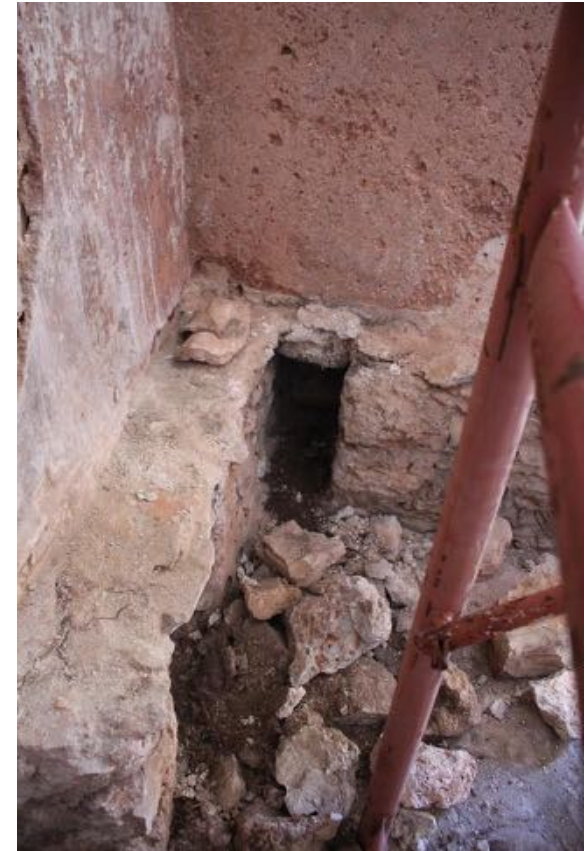
# Unblocking of the smoke pipes

*At the level of the hypocaust*

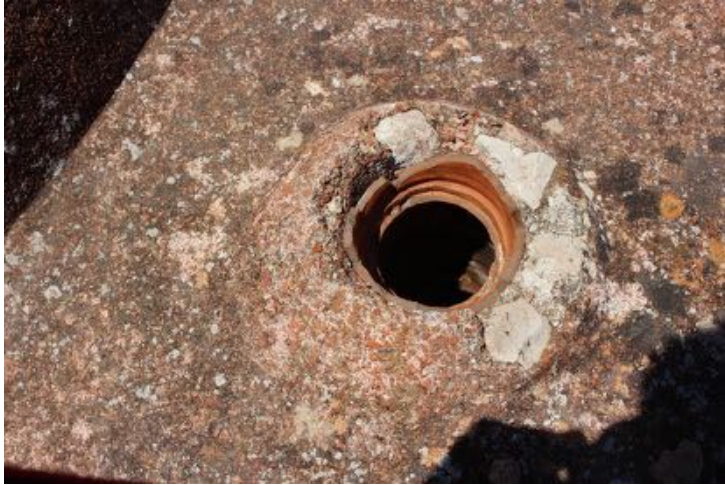
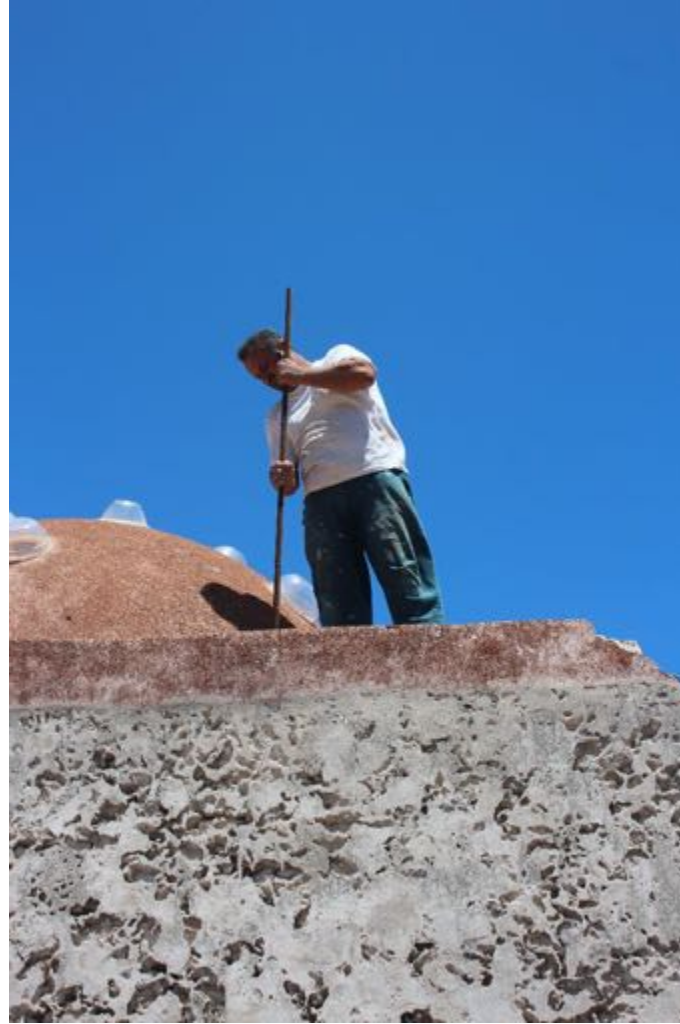
# Unblocking of the smoke pipes

*From the flat roof*

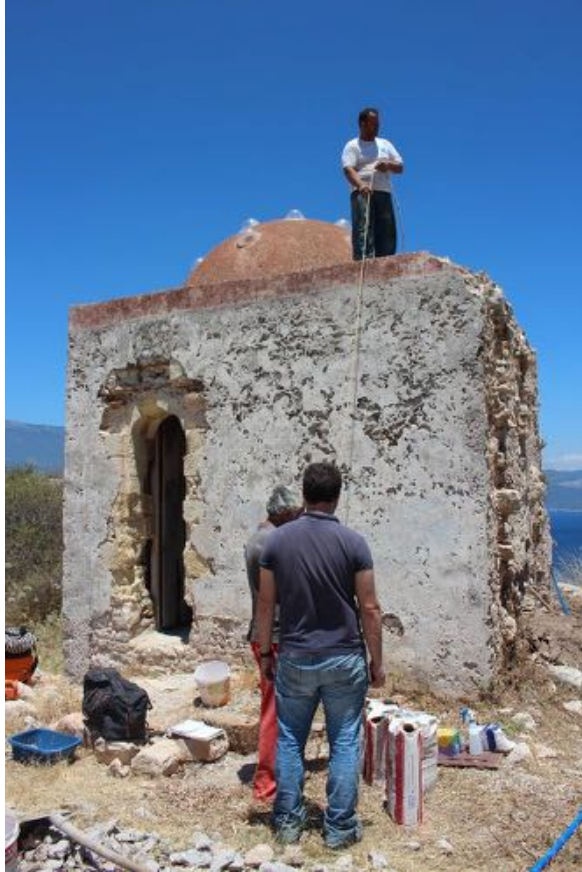
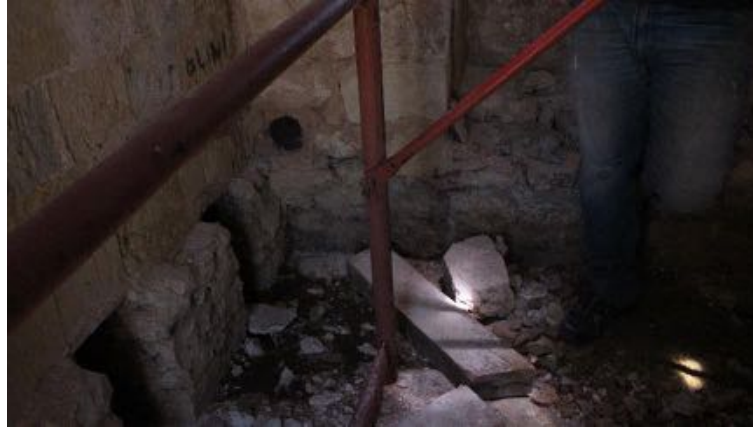
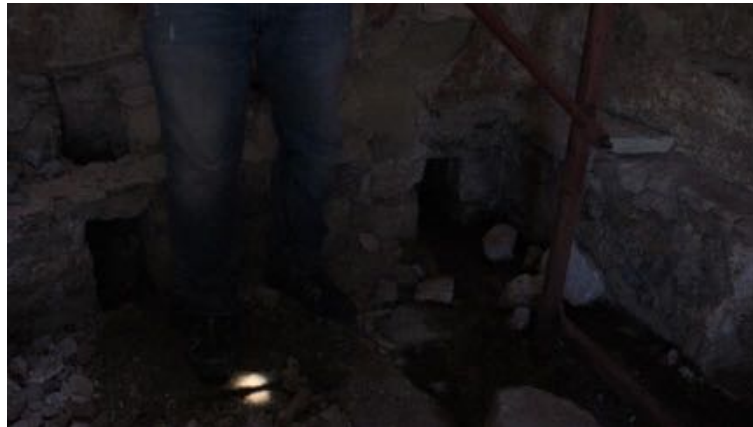
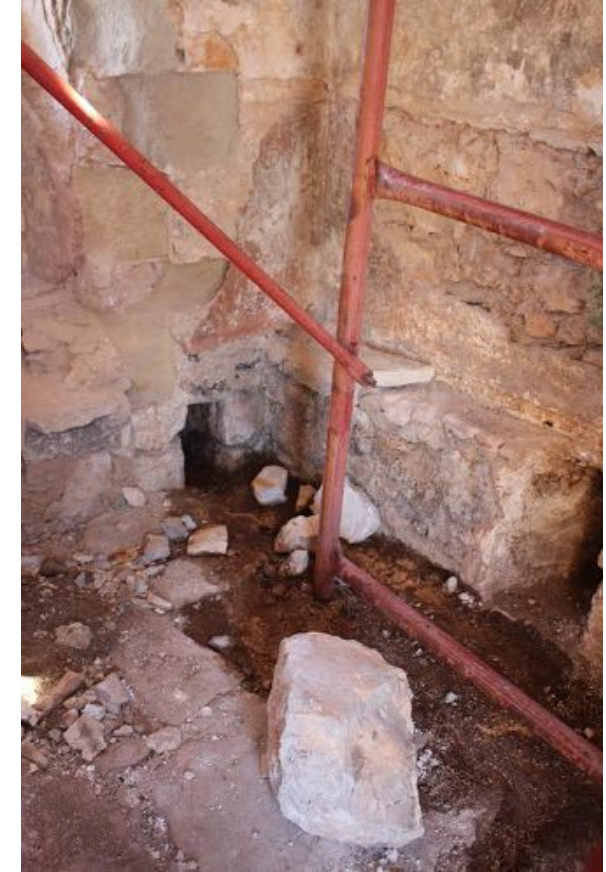
# Checking the unblocking of the ceramic pipes for the smoke by throwing water into it

*Flat roof- inside the hammam*

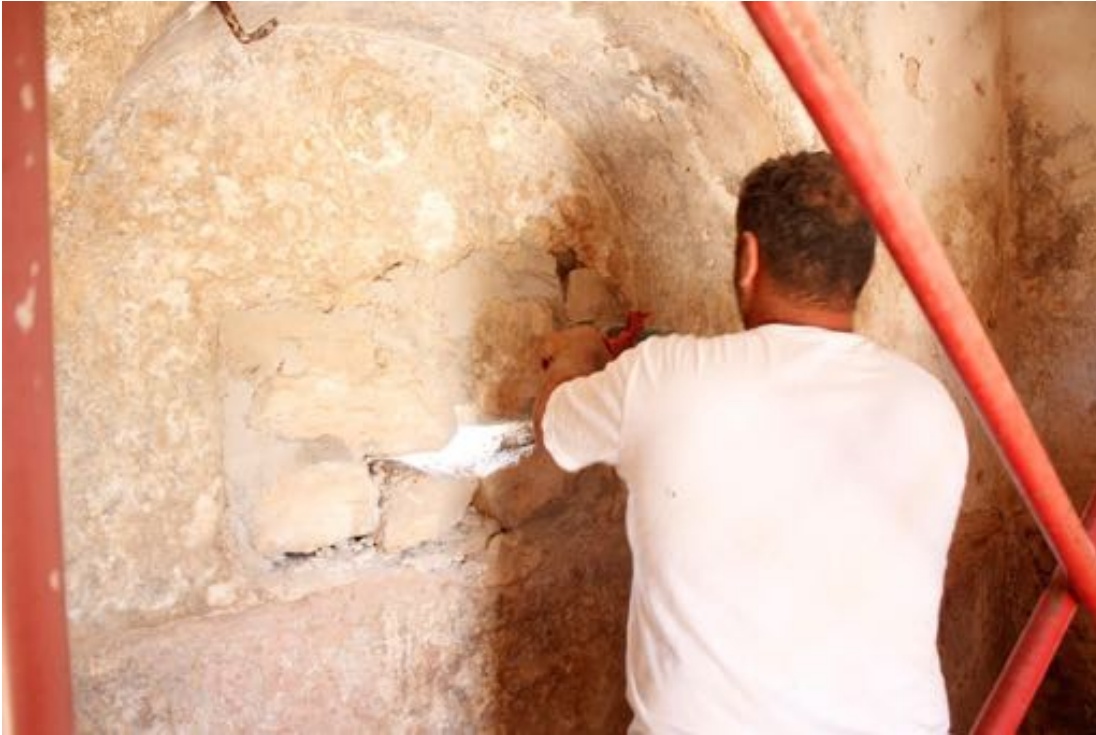
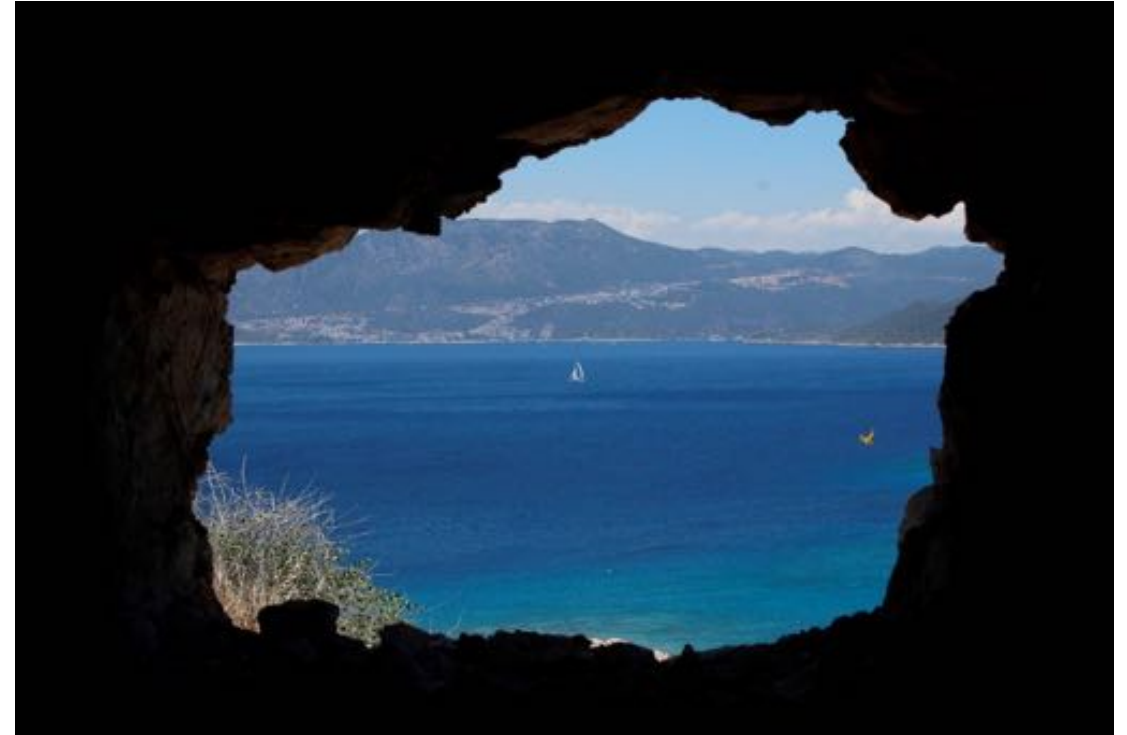
# Unblocking the window towards the sea

*Niche of the north wall*

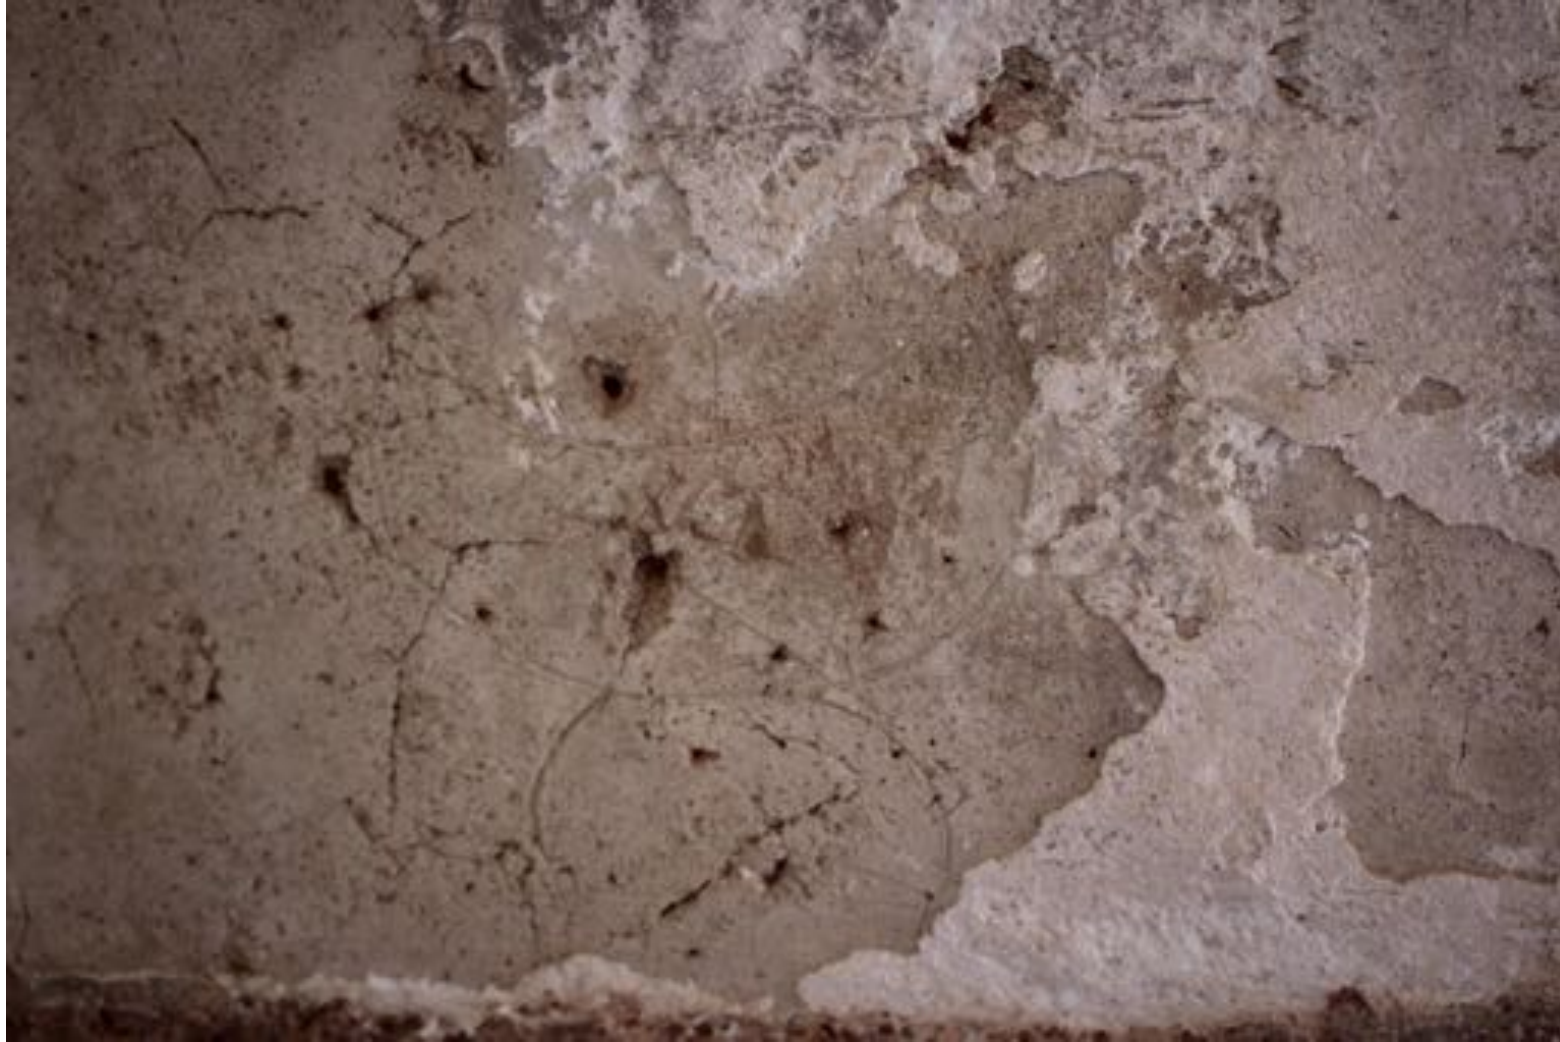
# Various

*Half moon (muslim symbol) on the wall- graffiti*

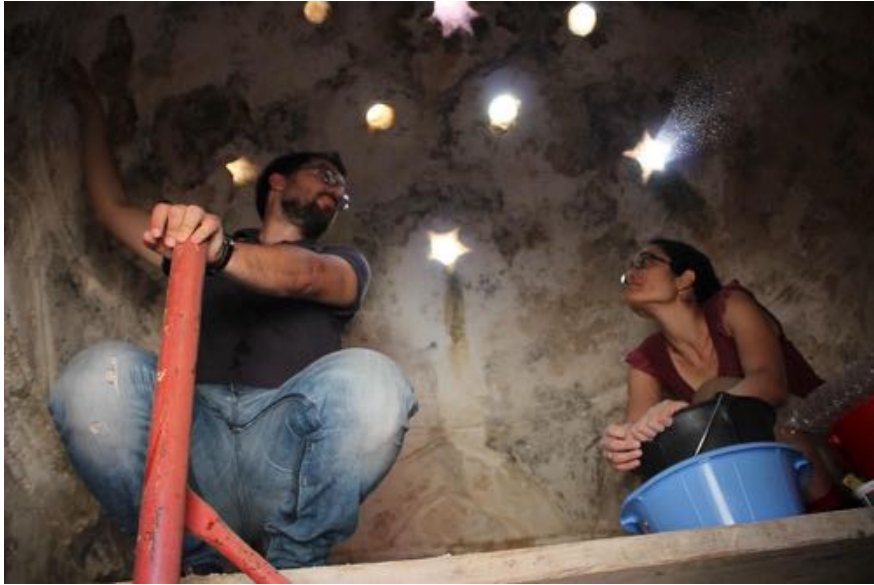
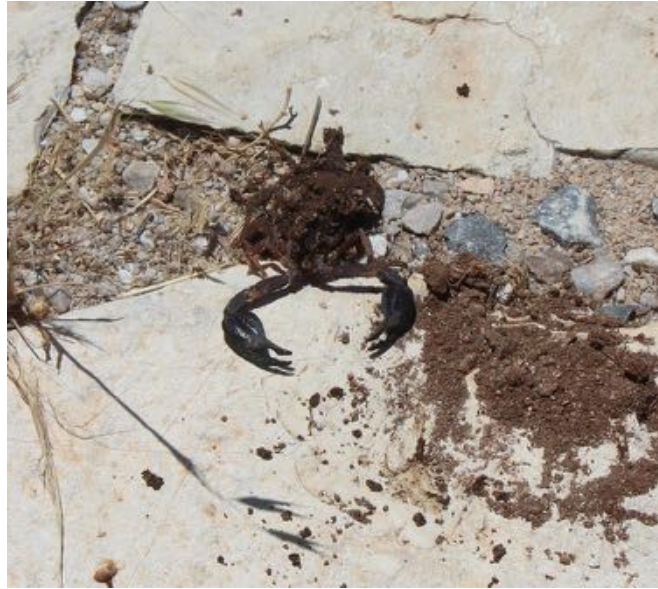
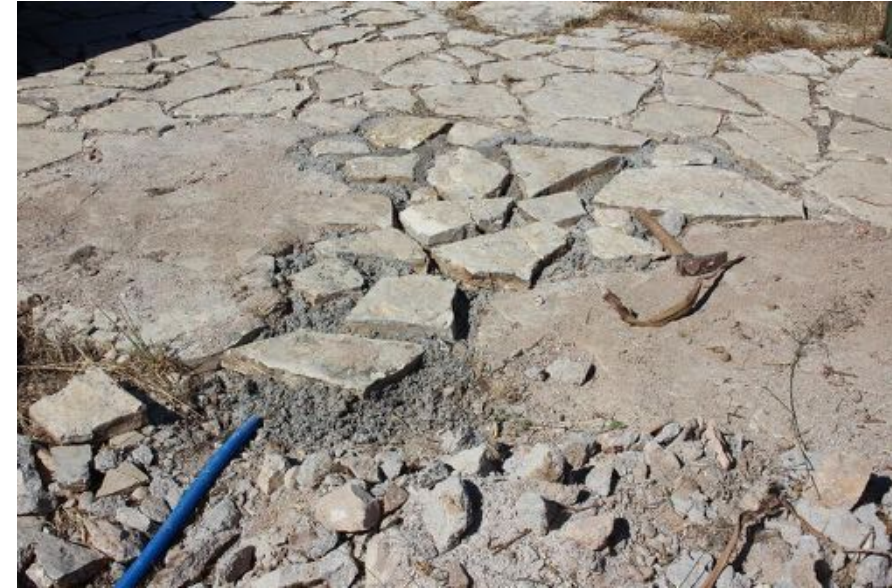
# Various

*Talking about basic guidelines for the wall conservation/  
scorpio inside the furnace/  
connection to the water system*
